NOBLE ROT

Instead of making a neglected building look brand-new, why not refurbish it to preserve and showcase the damage worked by fires, damp, squatters and the passage of time? **Ike Ijeh** explores the advantages of growing old gracefully

ALEXANDRA PALACE THEATRE

Architect: Feilden Clegg Bradley Studios
Contractor: Willmott Dixon

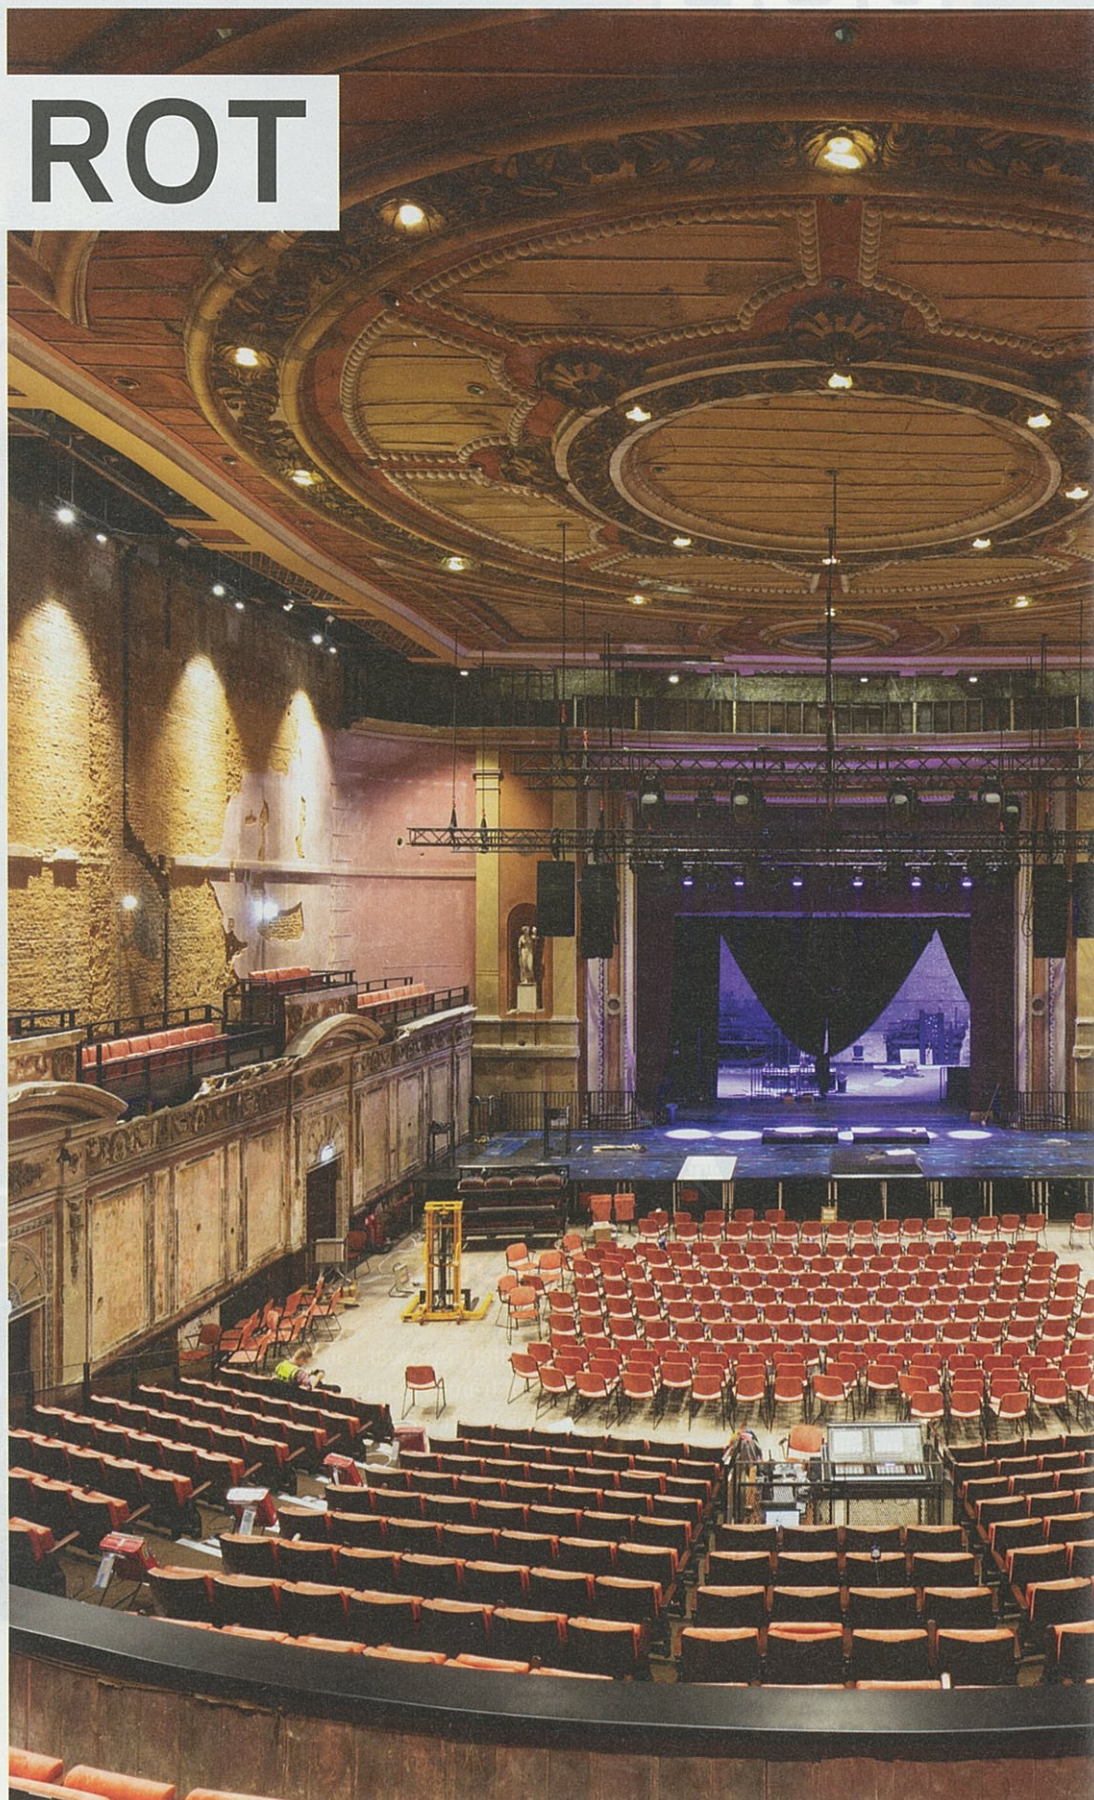
While the walls and ceiling of the Alexandra Palace Theatre have been made structurally sound, signs of wear and dereliction have been retained

The result is essentially a gloriously atmospheric evocation of a working Victorian ruin in a section of the building that has remained disused and unoccupied for an astonishing 80 years. Crumbling plasterwork has been maintained on both walls and ceilings, but hidden behind these lies an ingenious array of discreet structural stabilisation methods. For the walls, Willmott Dixon construction manager Tony Dowling reveals that "we repaired any structural cracks in the brickwork but all cosmetic ones were retained and closed with a lime plaster sealant. The general concept for the walls was to remove anything loose but beyond this to touch as little as possible."

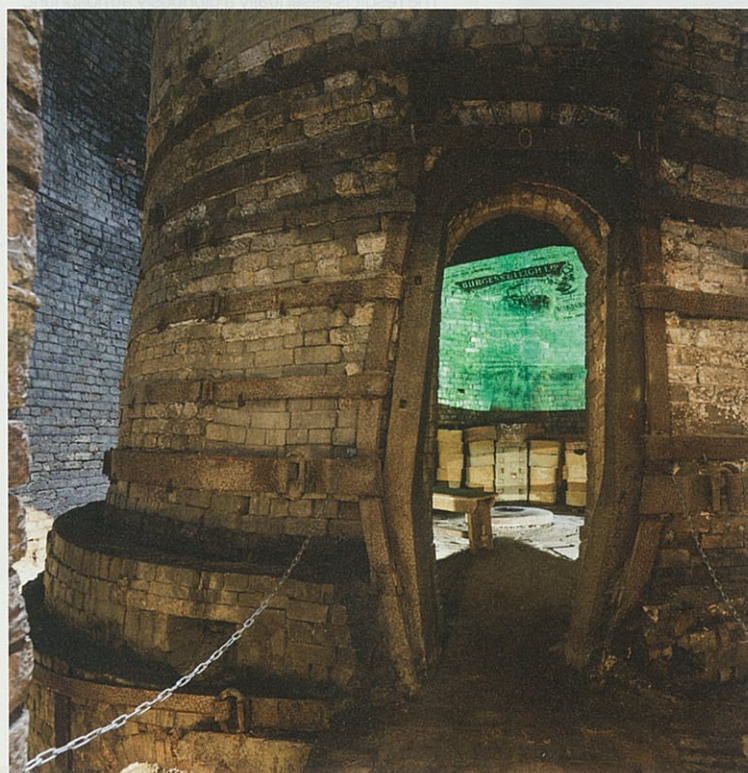
The remaining bottle kiln at Middleport Pottery has been converted into a meeting room (left), while a series of 'conservation primers' guided refurbishment of external and internal fabric

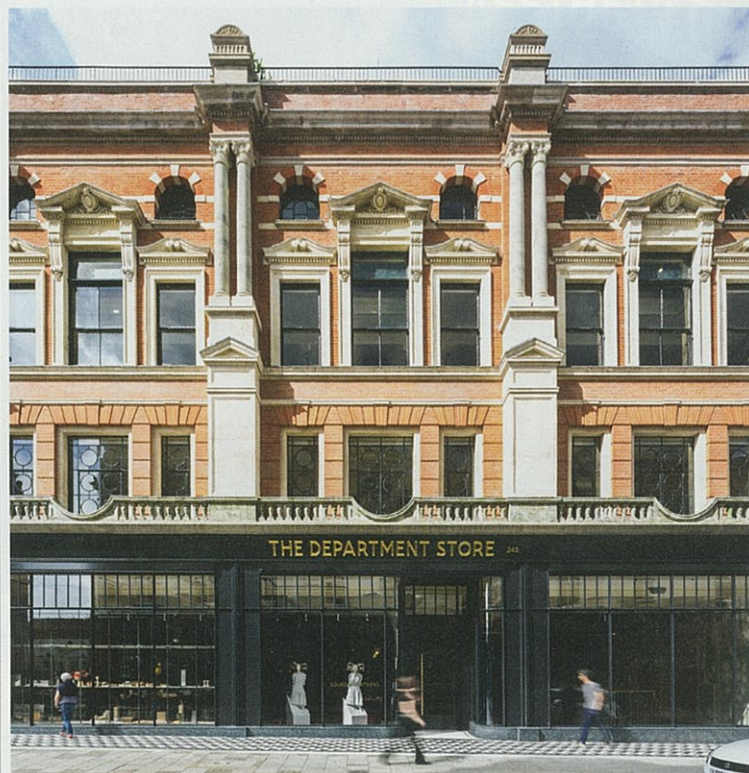
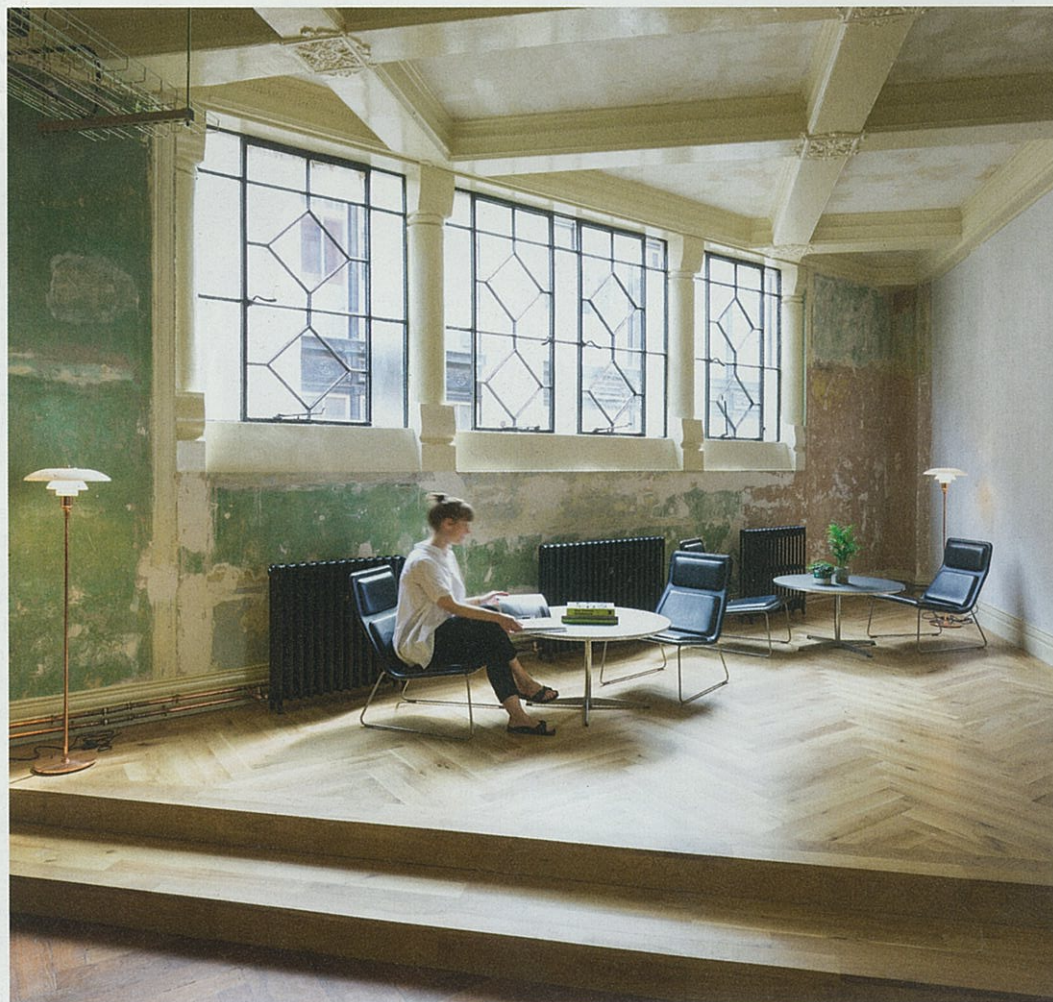
Despite boasting a grand facade (right), internally the Department Store has been stripped back to its faded core

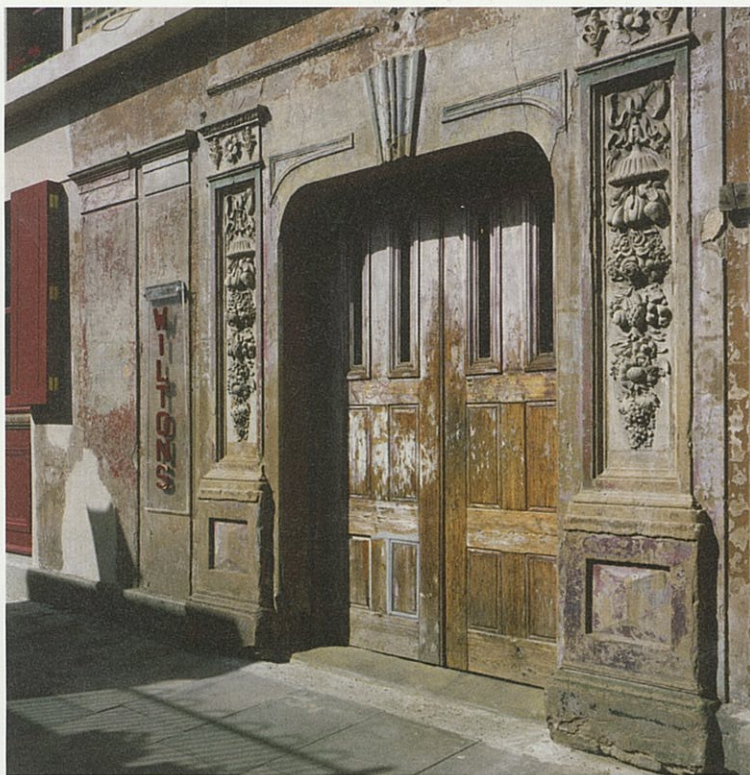
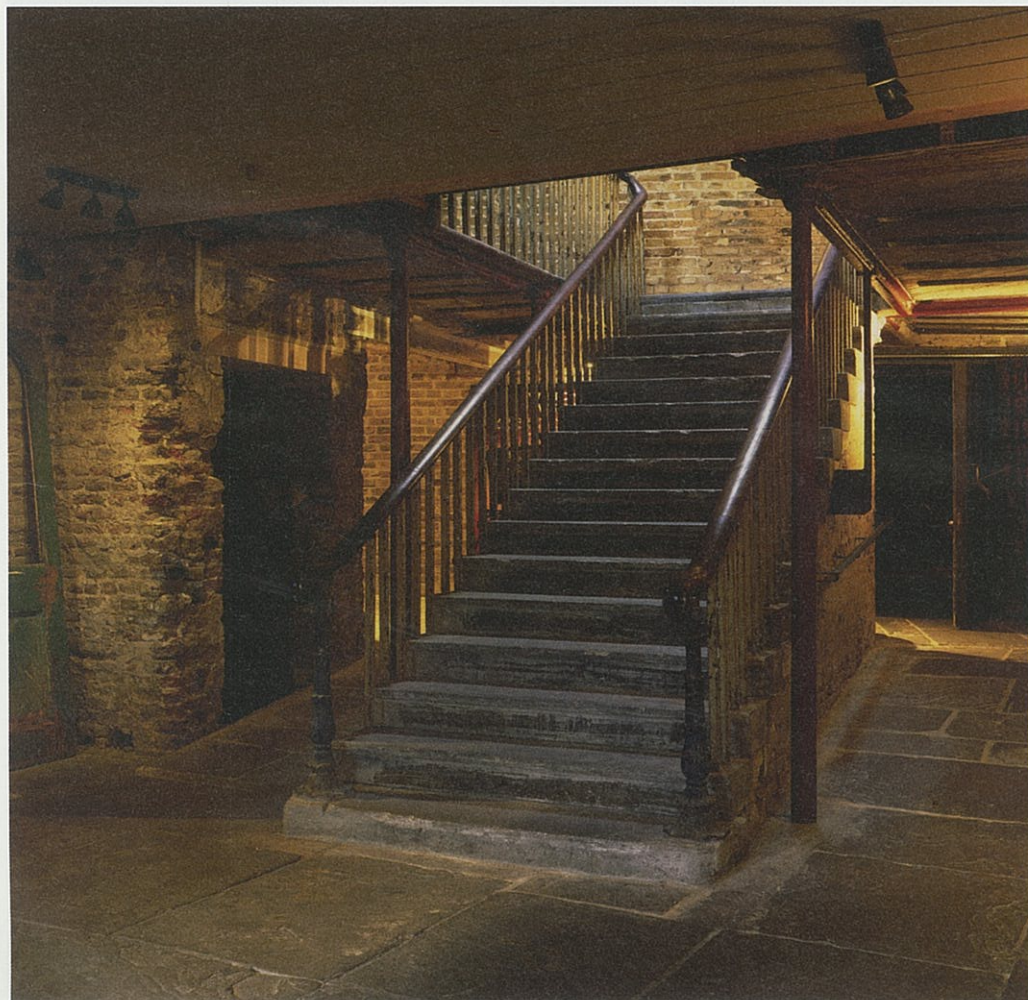
*The addition of new signage
is the only external clue to
Wilton's renovation (left),
but inside its 'ruined'
Victorian atmosphere has
been carefully maintained*
